Report of Structural Inspection and Condition Assessment of Trimming Room - Areas 2 & 3 and Press Room - Area 12 at the Former Bossert Manufacturing Facility

Utica, New York

November 14, 1997

Project No. 24708.01

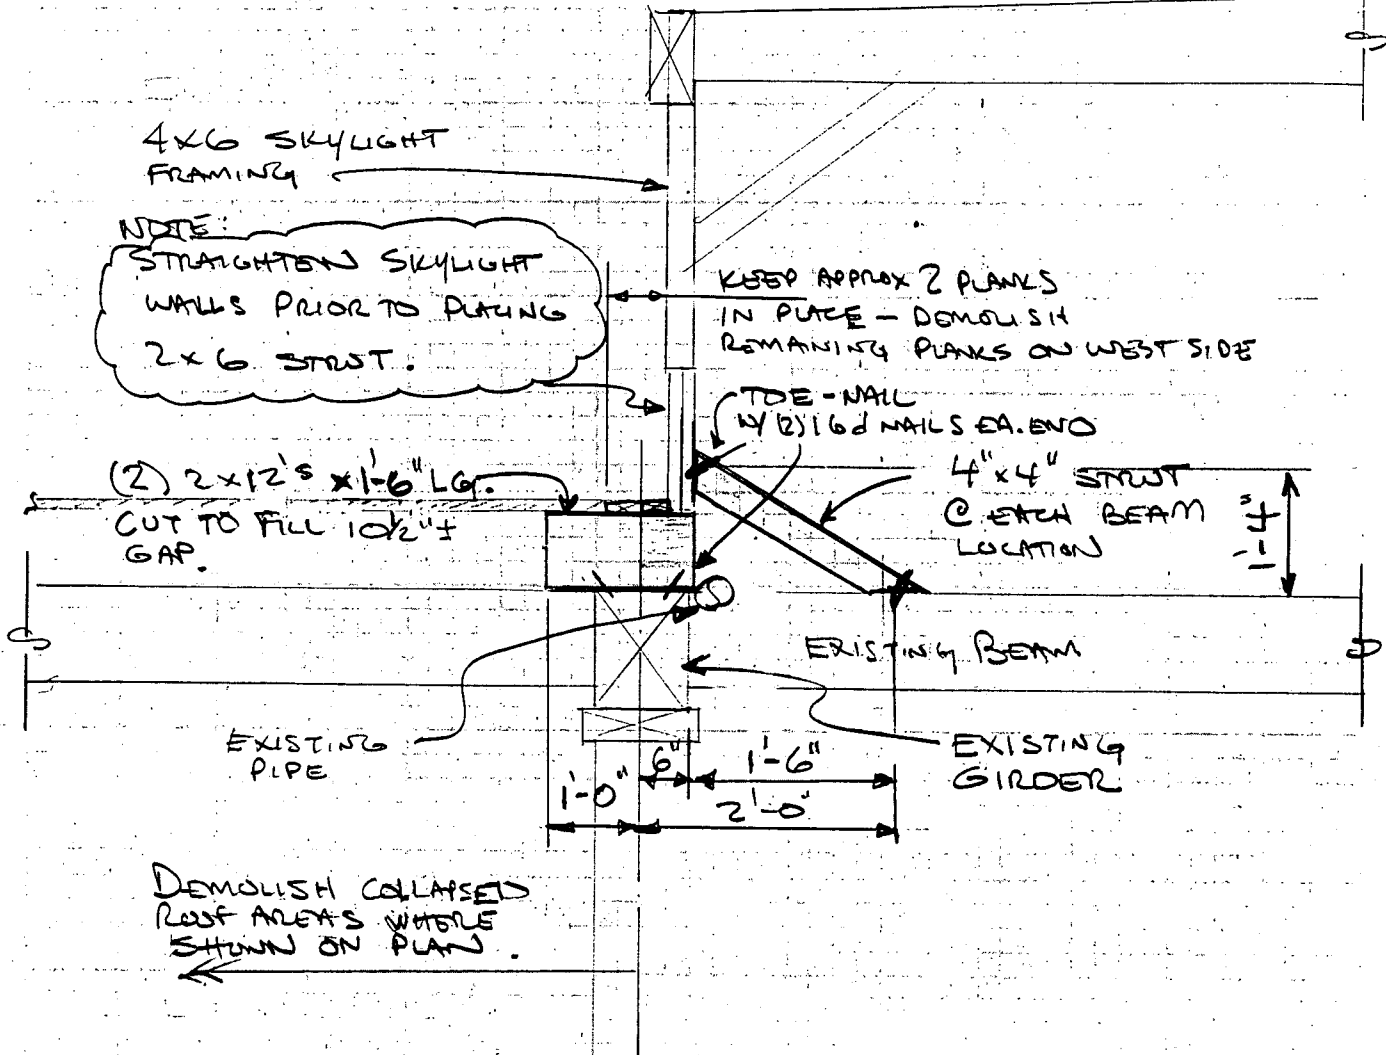
ELEVATION AT BEAM LOCATIONS

NORTH OF FRAME LINE 34

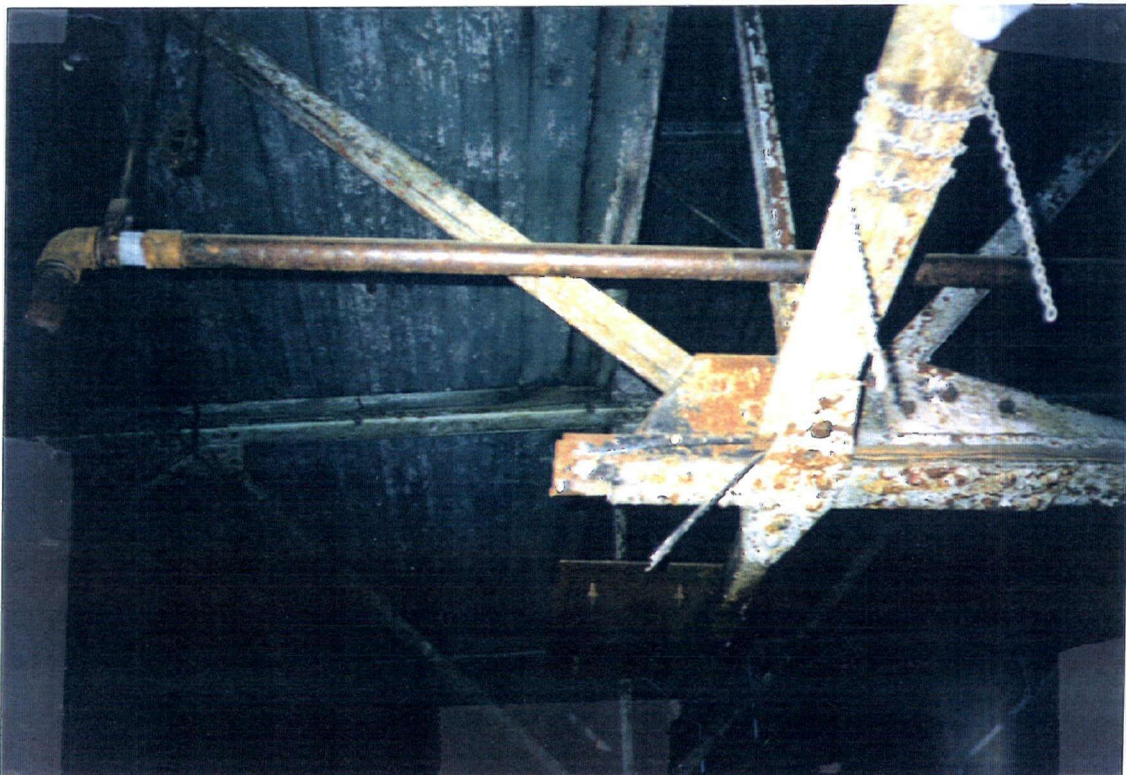
The 12" brick bearing walls are in generally good condition and support the ends of the steel trusses. The ends of the trusses are fully embedded in the brick masonry with no evidence of loose brick surrounding the truss ends. The overall appearance of the trusses show that they are well constructed and have less than 10% material loss at any cross-section. There are exceptions. Two (2) trusses exist with a missing lower chord member, obviously due to intentional cutting and removal likely at a time when the plant was operational. Specifically, the lower chord double angle $2L2\frac{1}{2} \times 2 \times \frac{1}{4}$ was removed and a gusset was severely damaged as shown on sketch Detail 1 of the APPENDIX.

An analysis of the truss indicates that the missing member is needed to transfer the "tension force" to the remaining members between lower chord panel points. A calculated tension load of 36 kips in this member is due to combined dead and snow load. A replacement member is required to be field welded at the two (2) affected trusses.

AREA 2 **STEEL TRUSS HAS MISSING LOWER
CHORD MEMBER AND DAMAGE TO
PANEL POINT GUSSET**
